RESEARCH CONSTRUCTION REPORT

CIR-EE (COLD IN-PLACE RECYCLE ENGINEERED EMULSION)

Location: Red Lodge, Montana- Carbon County
Highway 212, P-28

Project no.: Red Lodge - North STPP 28-2(22)70

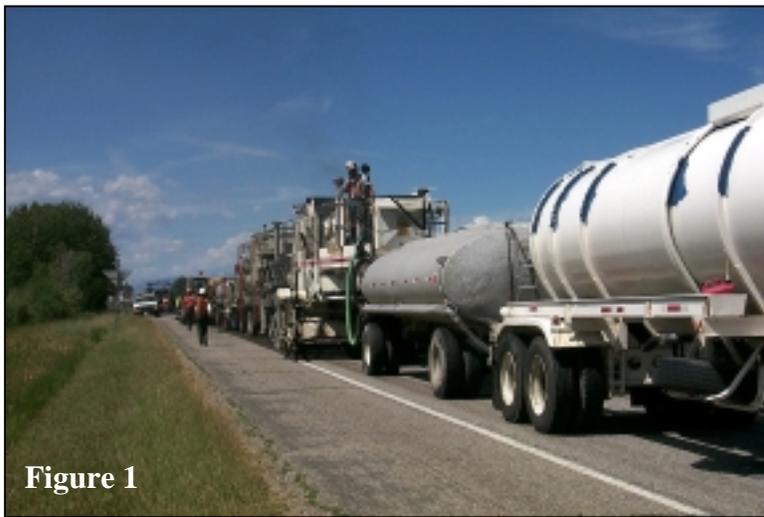
This project began at milepost 91 and ended at milepost 101.5 (approximately 10.5 miles, 19.9 kilometers). Figure 1 is showing the view of the front of the recycle train.

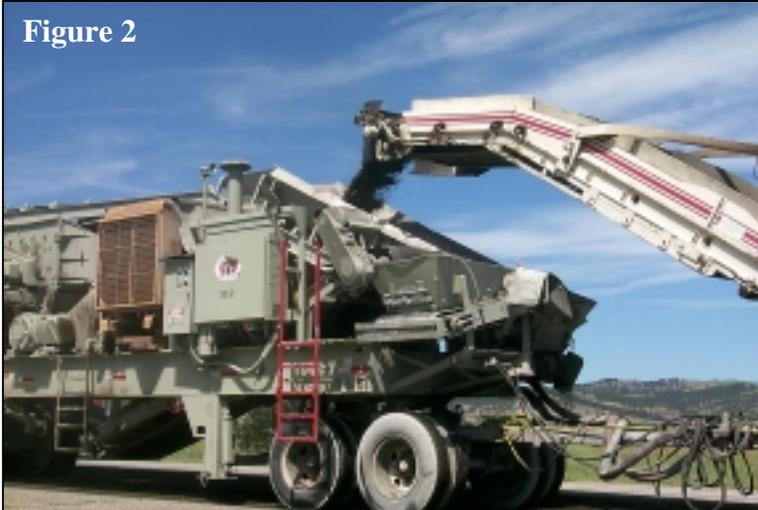
Figure 2

The milling machine conveyed the millings to the crusher apparatus to adjust gradation according to specification (figure 2). The material was then fed into the pug mill where the Koch CIR-EE emulsion was proportionally mixed into the rap (figure 3). From here conventional asphalt paver laid the prepared recycled material as seen in figure 4. The initial appearance of the mat showed adequate coating of aggregate. The appearance of the mat

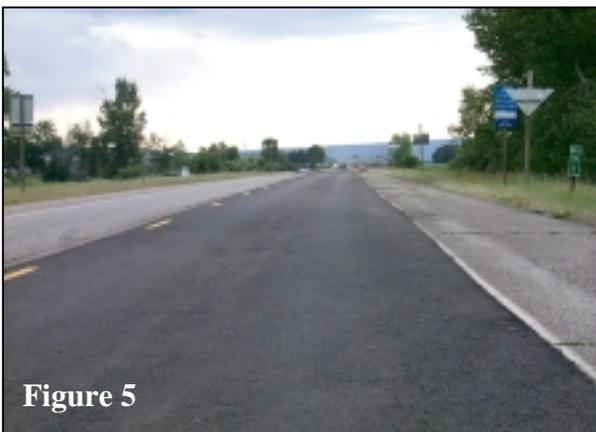
improved over the course of the project. Coring was attempted but during the core, the samples fell apart or crumbled. Koch representatives were not concerned, and stated this was normal for the process. Figure 5 shows the in-place at milepost 91 looking north.

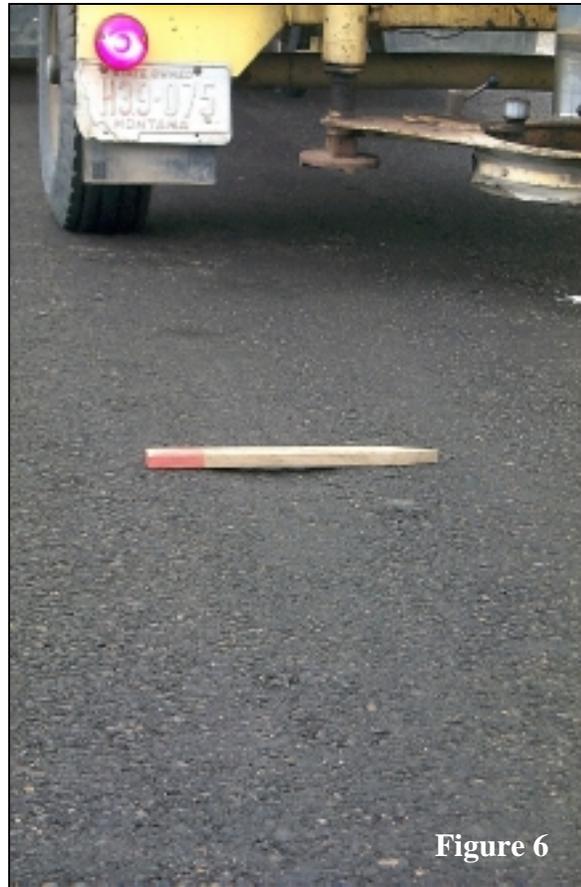
During the coring process, it was noticed that the wheels of the coring unit (while stationary and performing the core) rutted to an approximate depth of 10-12 mm (as seen in figure 6). Koch had assured that this apparent tenderness would firm up in a matter of days. From this, traffic control did not let vehicles wait on the mat, they were led through without stopping.
